Title
2015 AIS Survey: Alpine Lake Eurasian Water-Milfoil

Client/Project
 Alpine Lake District
 2015 Alpine Lake AIS Treatment

Project Location
 T18N, R11E, S04
 T. of Marion, Waushara Co., WI

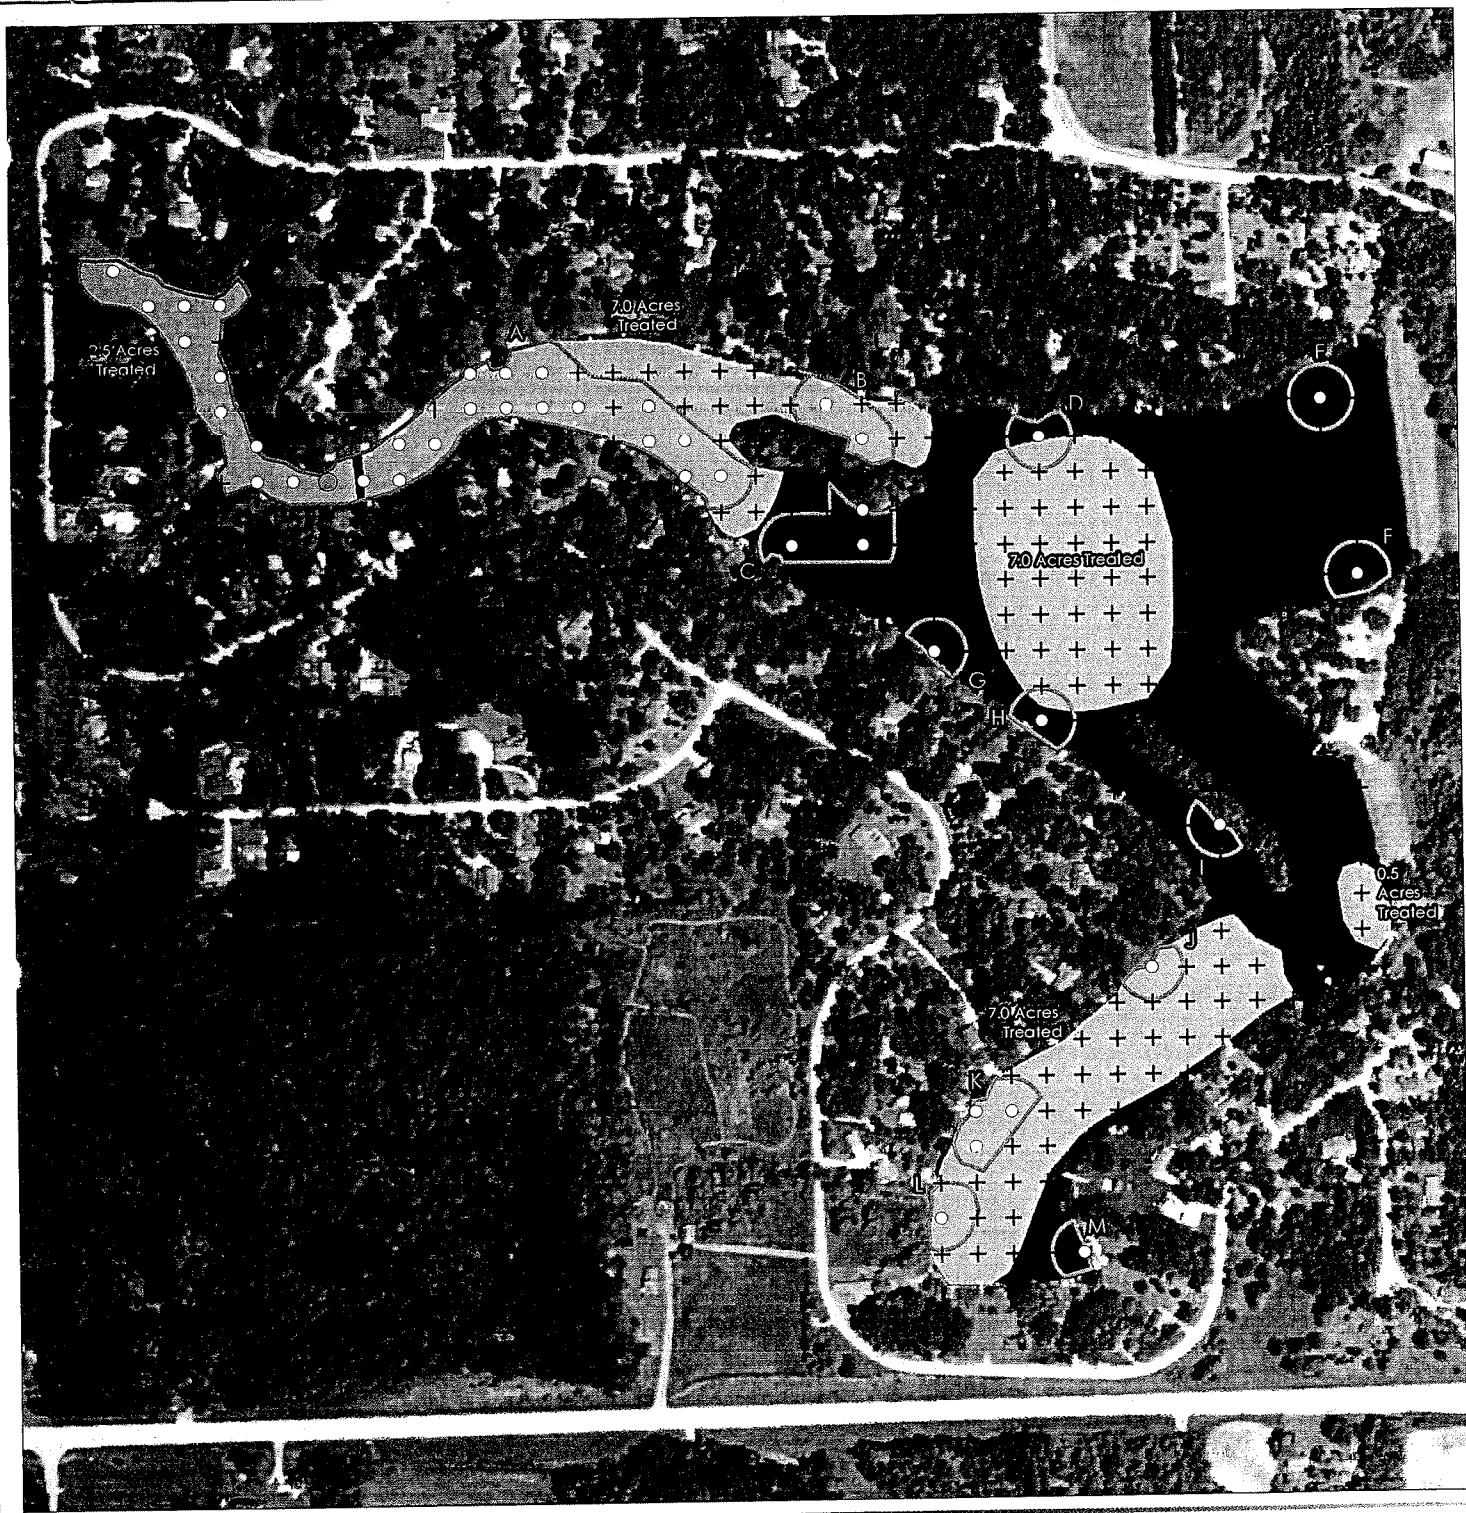
Figure No. **1** **DRAFT**

Eurasian Water-Milfoil (acreage)			
A	6.29	H	0.39
B	0.76	I	0.26
C	1.02	J	0.31
D	0.43	K	0.66
E	0.5	L	0.42
F	0.42	M	0.22
G	0.32		
Total = 12.00

*Survey completed by James Scharf & Chris Caplan on 2015/08/18
