SILVER LAKE INFLOW POINTS

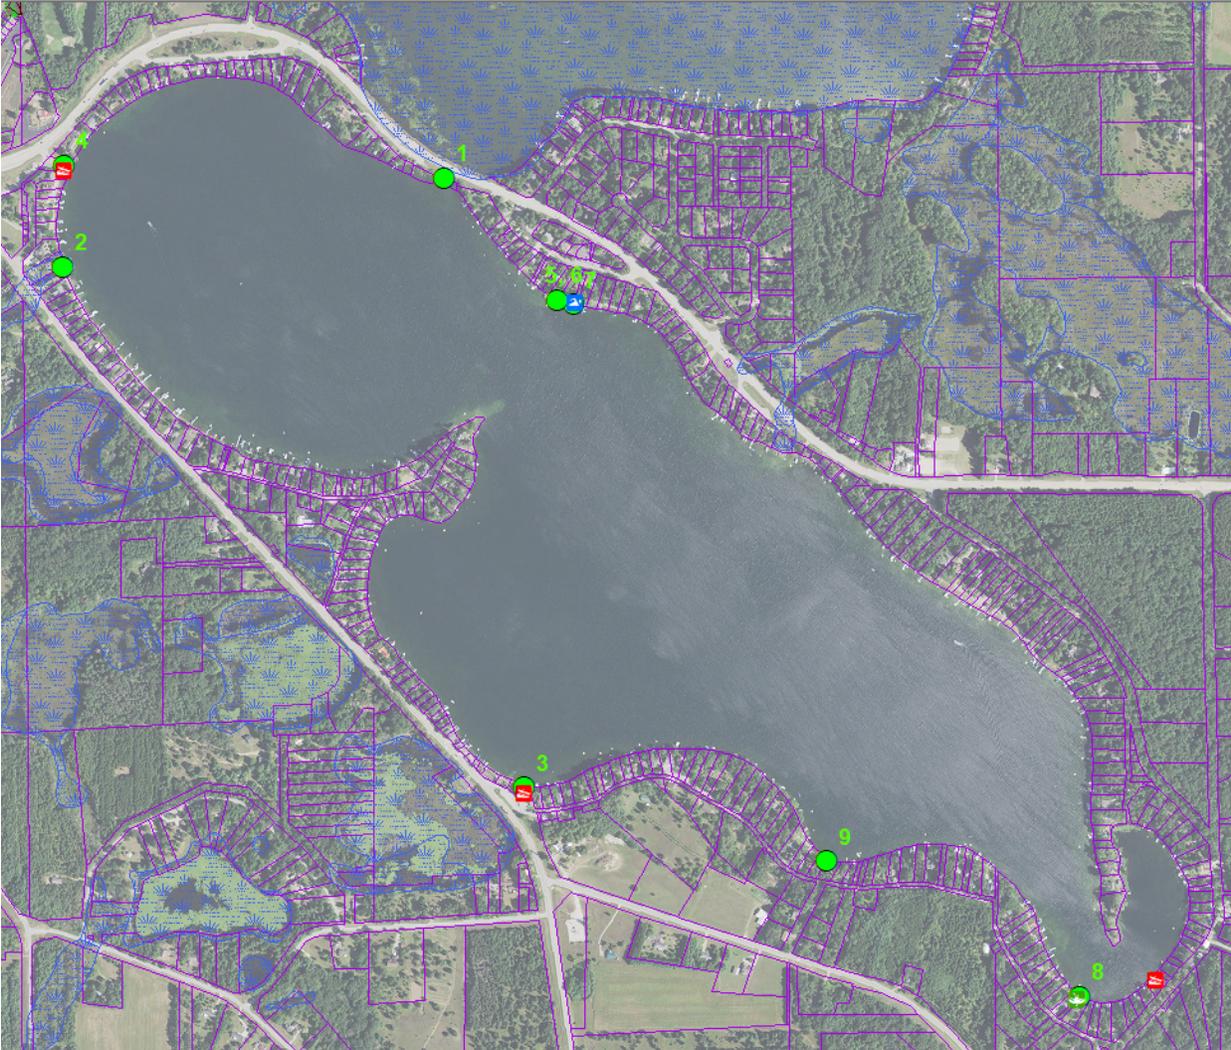
1. Highway 21 Culvert connecting Silver Lake and Irogami.
 - a. Concrete Lip on Silver Lake side is 867.41 ft
 - b. Concrete Lip on Irogami side is 867.61 ft
 - c. Water normally flows from Irogami into Silver when conditions warrant

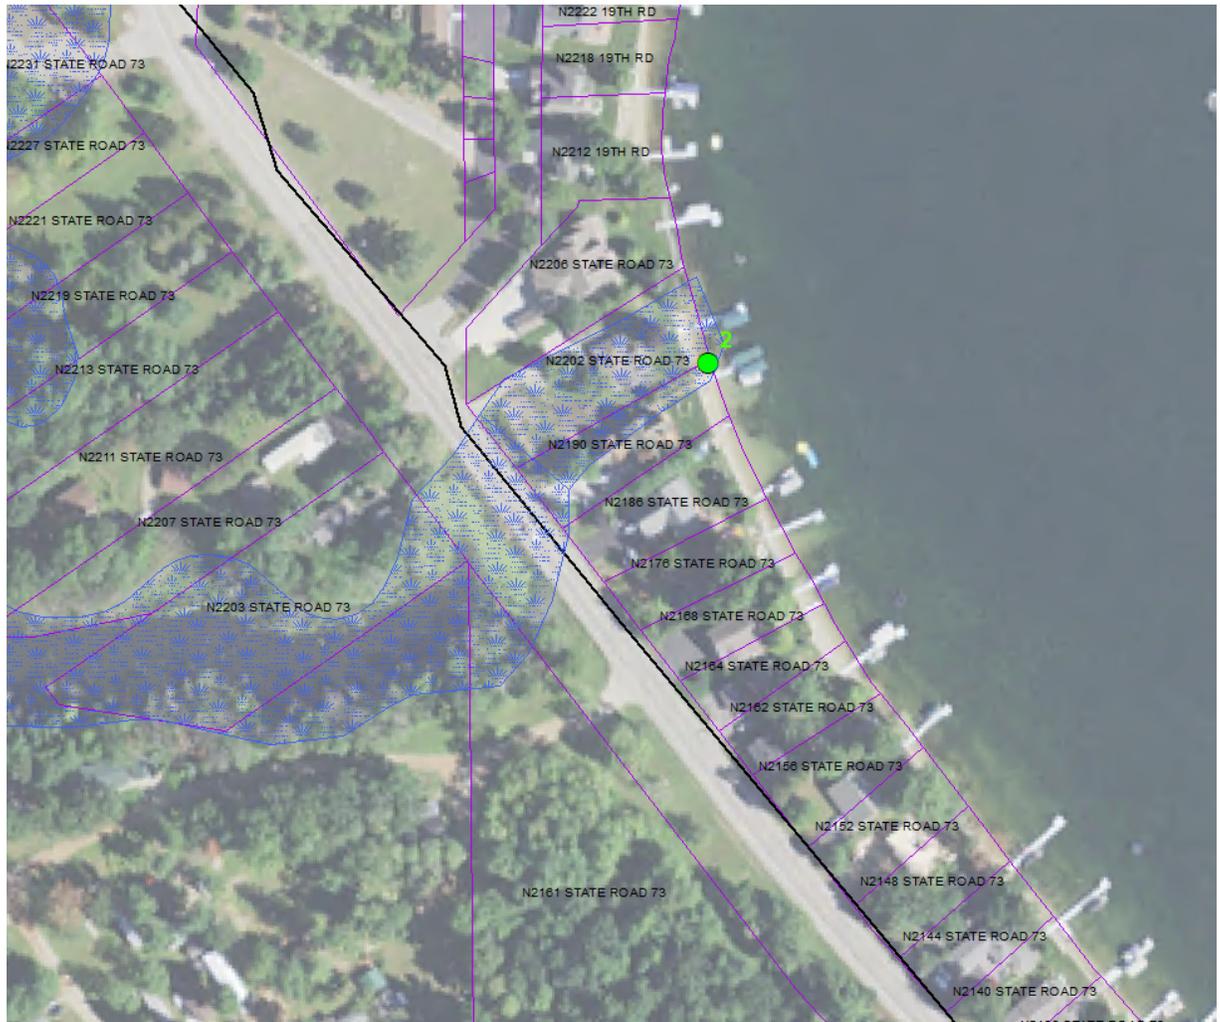
2. 24" Highway 73 culvert from Booth's Marsh.
 - a. Under highway 73, just east of Hwy 21 and 73 stoplights
 - b. Water from Booths Marsh flows into Silver
 - c. Flow into Silver Lake is consistent. Heavy rainfall you can notice a plume of Booth's marsh water from the discharge pipe into the lake.
 - d. Discharge into the lake is located between the residences on N2022 AND N2211 State Highway 73.

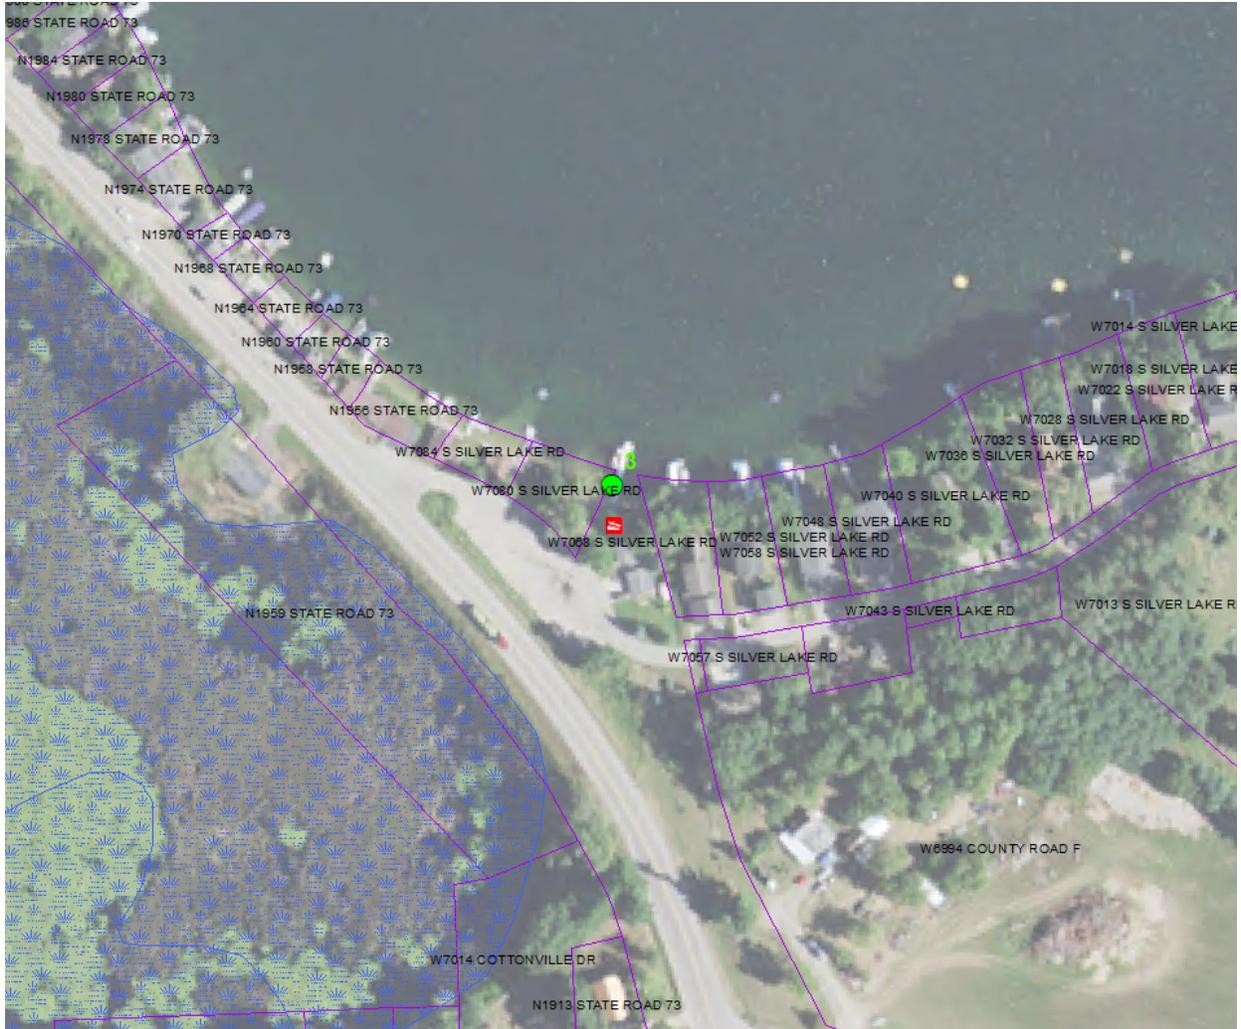
3. Highway 73 boat landing.
 - a. Asphalt parking lot drains into Culvert on west side of ramp into lake.
 - b. Also handles approximately 1,000 ft of runoff from S. Silver Lake Road which flows into trailer parking lot.

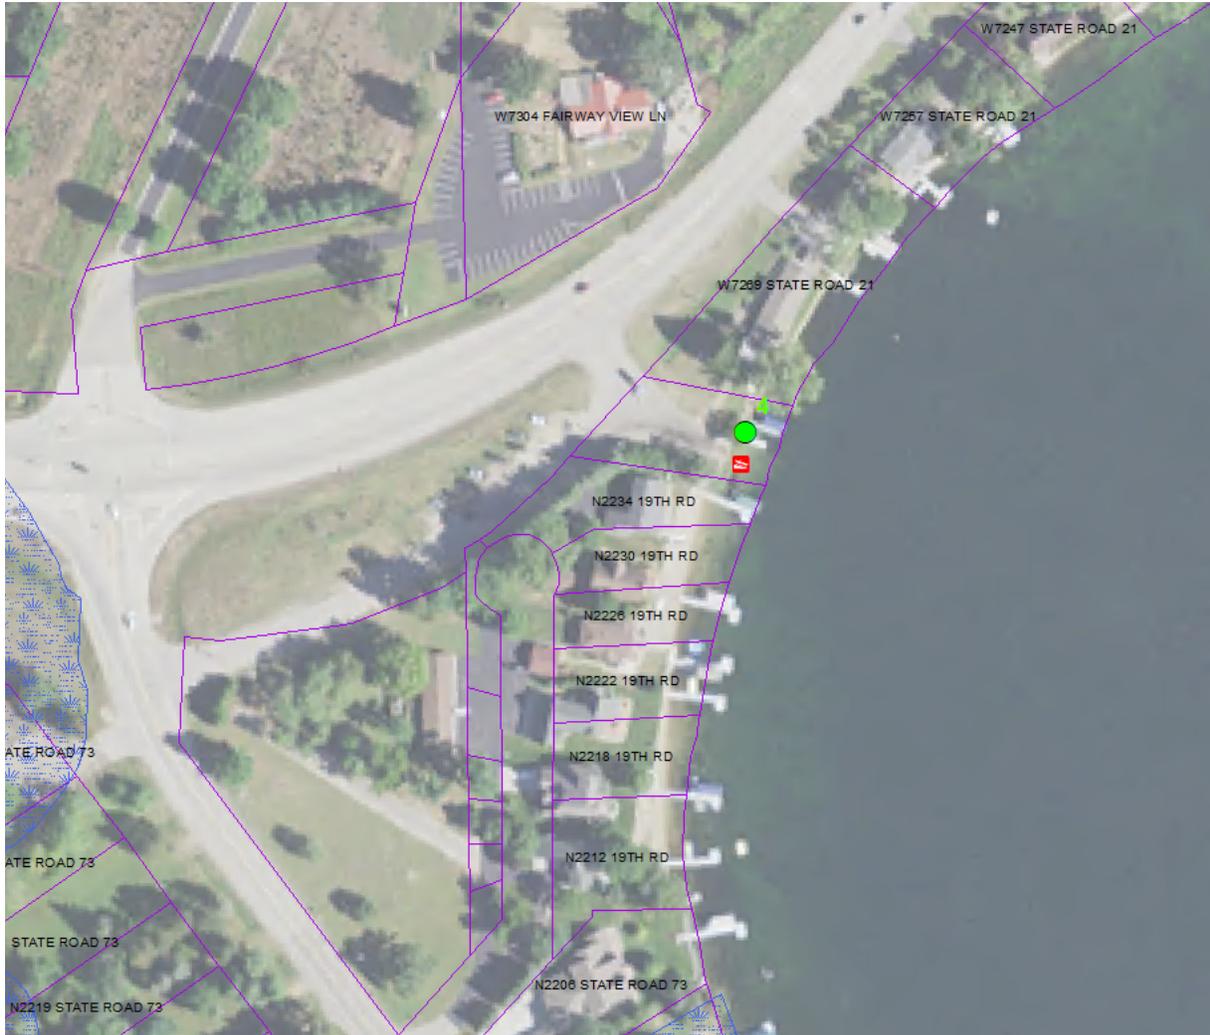
4. Highway 21 and 73 boat landing.
 - a. Culvert outlet on north side of ramp approximately halfway down ramp.
 - b. Catch basin handles runoff from paved ramp and turn around area and sand car/trailer parking area.

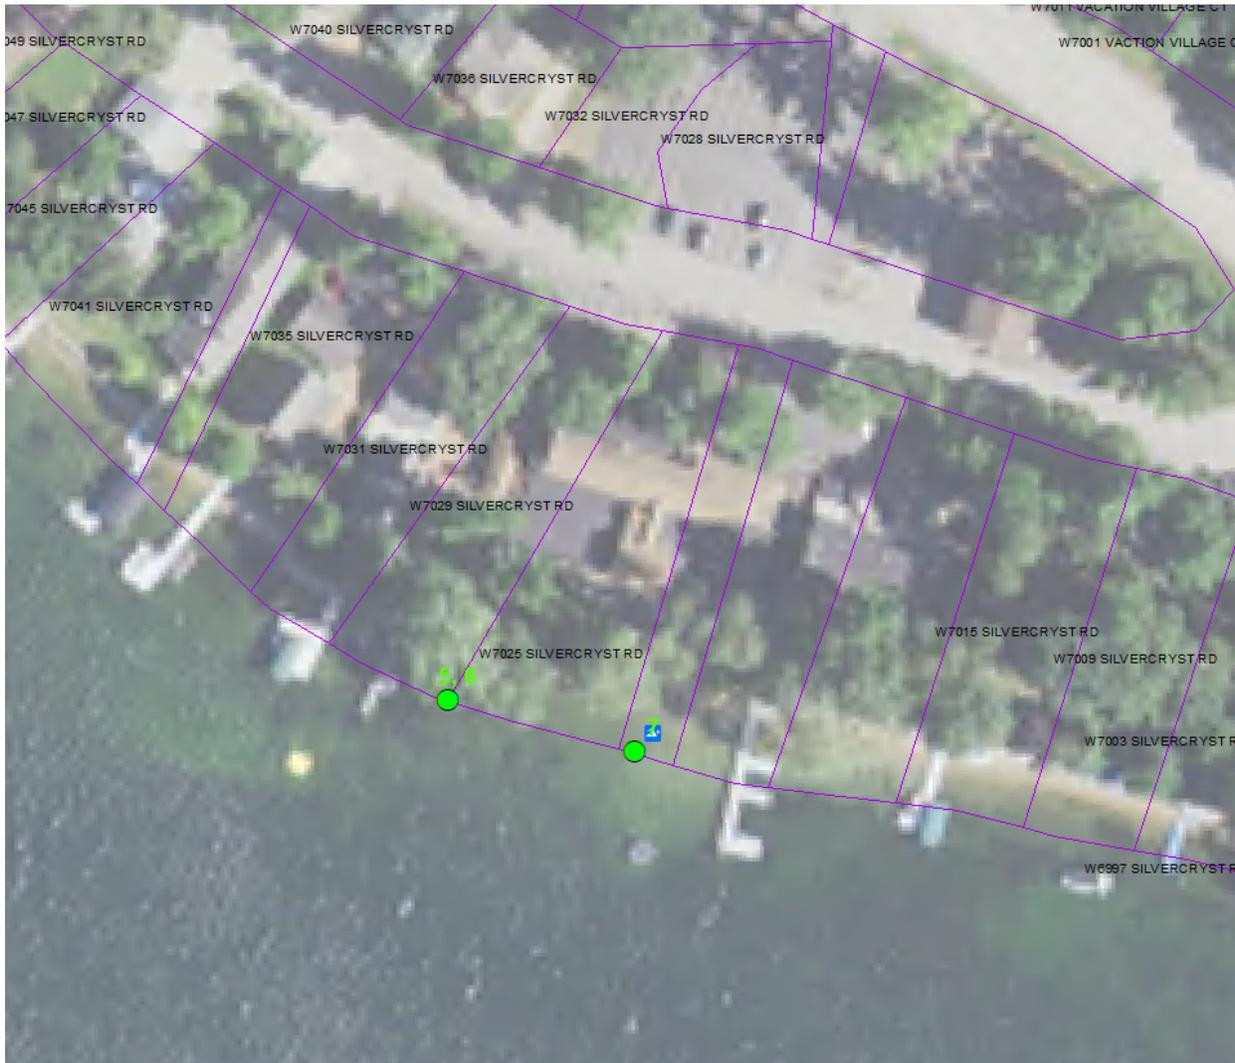
5. Catch basin on Silvercryst Road, behind W7029 Silvercryst Road which handles the runoff from Silvercryst Parking lot and Silvercryst Avenue. A small catch basin and 4" pipe inlet handle runoff from the Silvercryst kitchen driveway and land swallow (west of Silvercryst). A manhole on the east side of W7029 Silvercryst on the adjacent property provides connection points of small catch basin and 4" pipe to 12" pipe flowing into the lake. The 12" discharge into the lake is on the east side of the W7029 property. In storm events, this discharge produces considerable runoff into the lake.

6. Small 12x12 catch basin in Land swallow on the west side of 7029 property handles drainage from swallow between 7029 and 7031 Silvercryst Avenue. Discharge into lake is a 4" pipe. Rarely this inlet flows, water is usually absorbed into the ground first.

7. Silvercryst has a concrete apron and pipe in the middle of the beach area centered on the building. This apron handle runoff from the Silvercryst Motel area lawn, parking lot, and asphalt path down to the lake between the restaurant and motel. Runoff which is not directed into inlet 1 flows down this path.

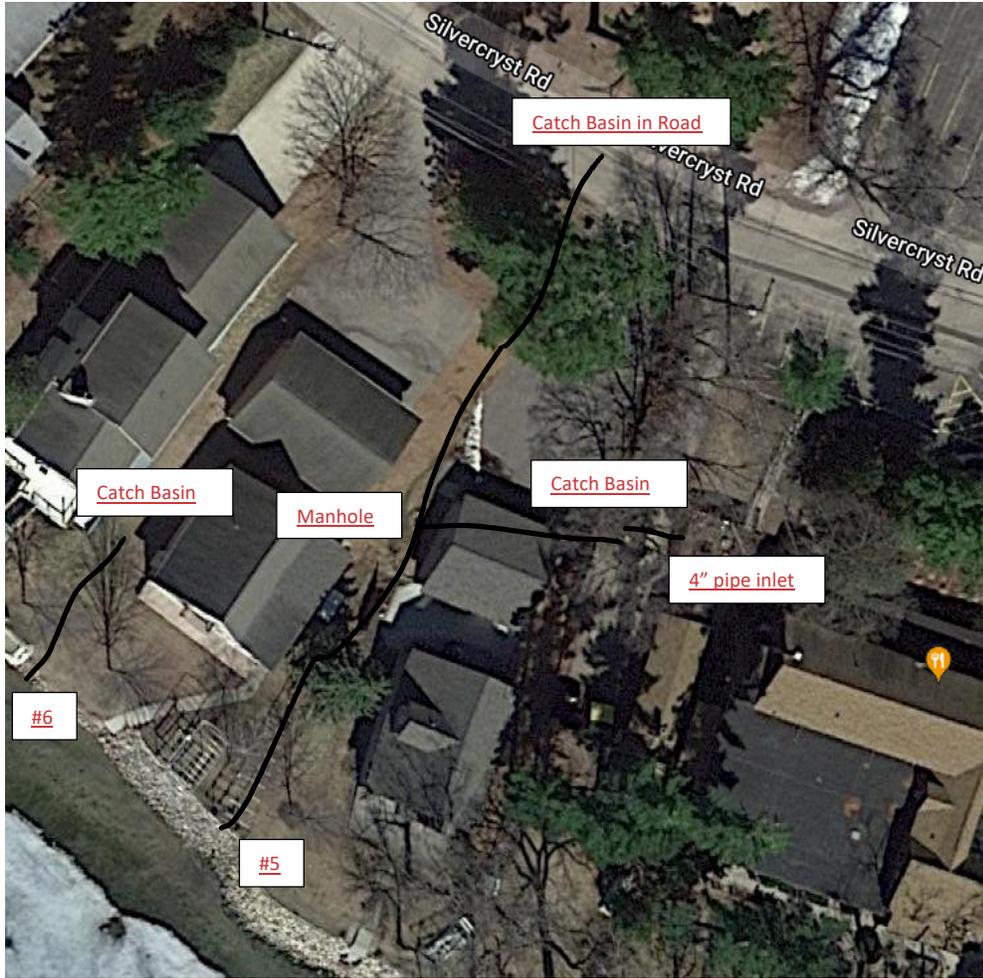
8. Town of Marion public access area on Silver Lake Road. Stairway to lake is located just east of W6764 S Silver Lake Road. There is rip rap under the stairs and platforms which allows runoff from South Silver Lake Road to cascade down into the lake.

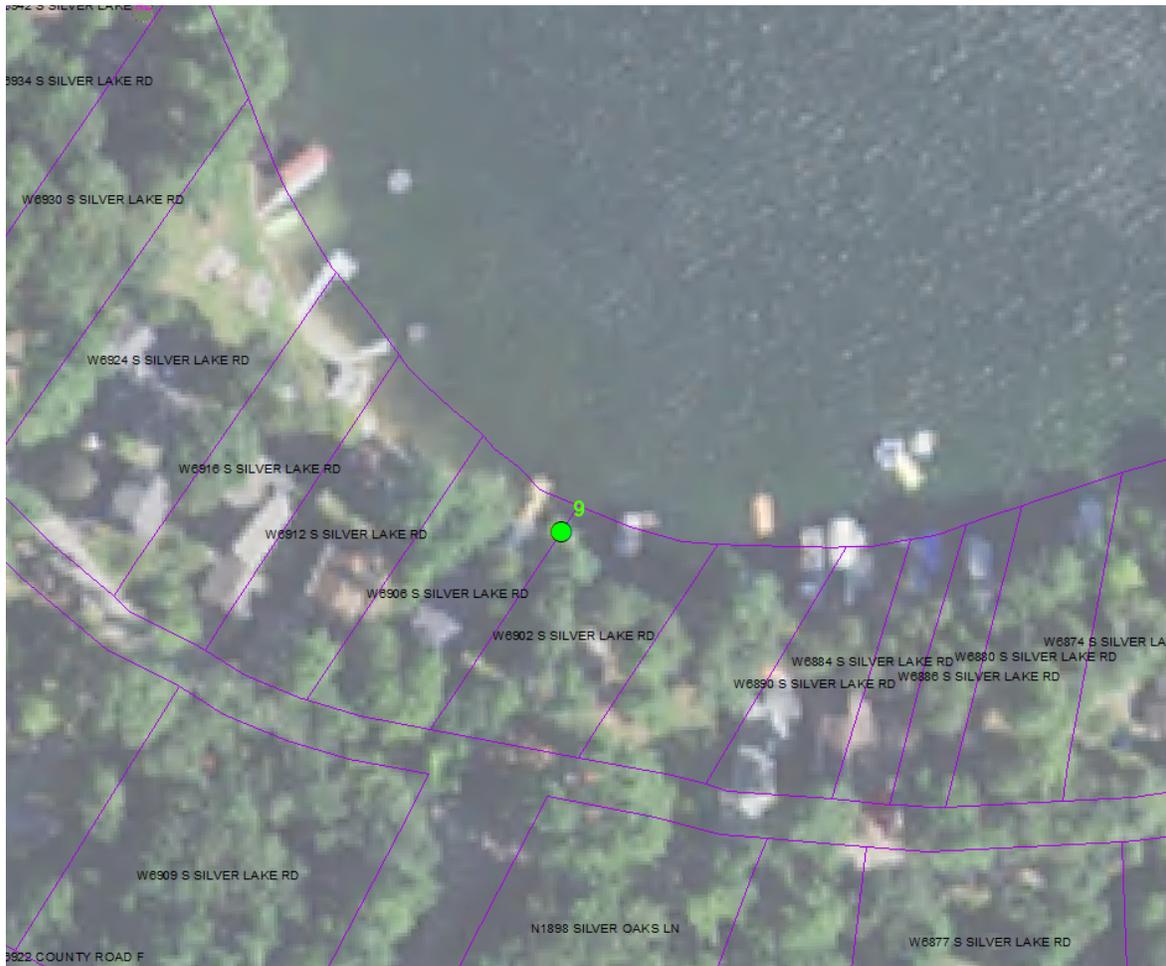
- Catch basin on the intersection of Silver Oaks Court and South Silver Lake Road. Street runoff is carried from there into a plastic culvert draining into the lake. Inflow from the pipe to the lake is the east side of the boat house located on the property at W6096 S Silver Lake Road.
